LEARNING FROM INCIDENTS

(Fire Eruption at an LPG Storage and Filling Plant in Sheikhpura in February, 2018)

(LPG Bowzer Overturned in Tehsil & District Muzaffargarh in January, 2021)

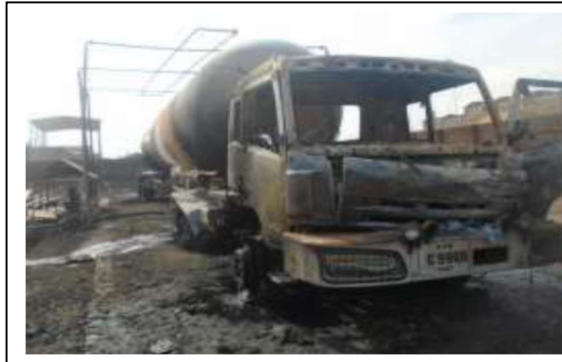
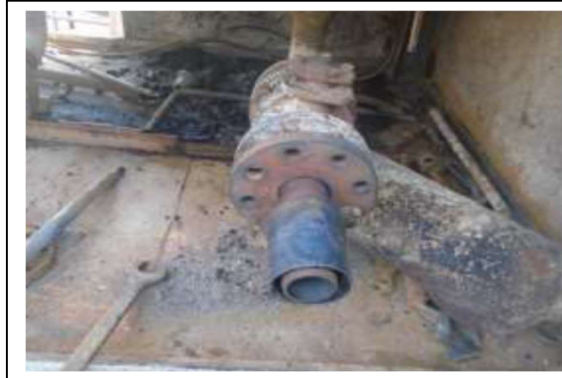
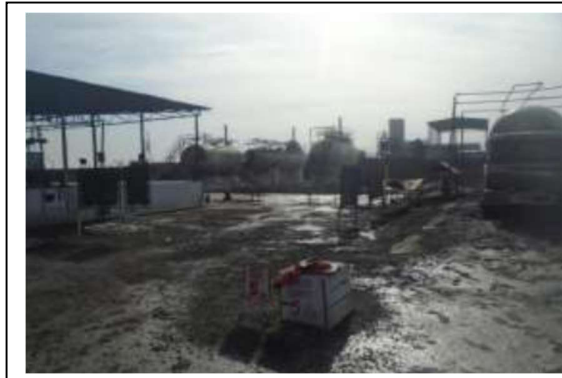
- Poor attachment between the Decanting Hose Pipe and Nozzle of LPG Bowzer due to negligence of the Bowzer's Operator/Decanter.
- Absence of Decanting Valve Spindle that hindered the Valve Closing efforts by the Bowzer's Operator/Decanter.
- Suspected Source of ignition was Electrical Circuit of nearby Paper Mills.

- Training of Technical Manpower of LPG Plants, Bowzers Drivers to cater to the Emergency Situations of all sorts.
- Inspection of LPG Bowzers and Attached Vehicles at Regular Intervals.
- Inter-Equipment Safety Distances be ensured.
- Awareness Campaign in the masses regarding handling of the Un-Controlled Hydrocarbons.

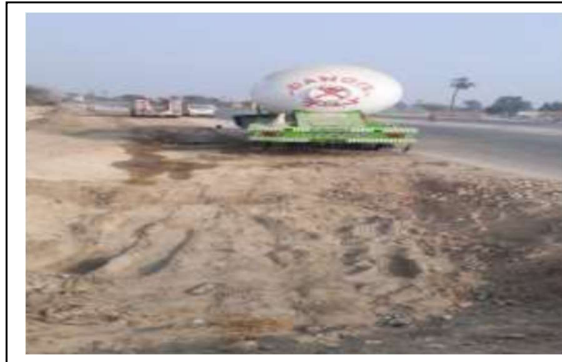
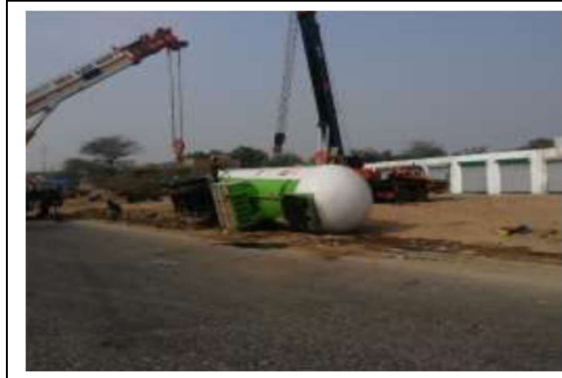
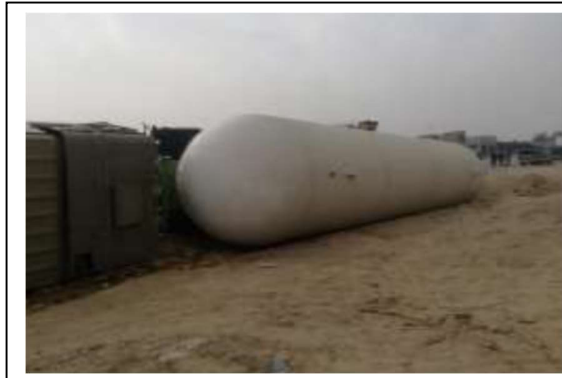
- Negligence of Driver is the probable Cause of the incident who was unable to judge the deep slope/trench on the left shoulder (Katcha) of the under-Construction By-Pass Road.
- Absence of any Helper of the Second Driver of the Vehicle which resulted in misjudged assessment of Long Vehicle on the Road's Shoulder.

- Appropriate Safety Trainings of the LPG Bowzers Drivers.
- Ensuring Deployment of Second Driver or Helper.
- Safe Movement of LPG Bowzers on Poor Conditioned or Under Construction Roads.
